New Generation Runway Visual Range (RVR) Final Operational Test and Evaluation Report: Volume III

July 1996

DOT/FAA/CT-TN95/32-III

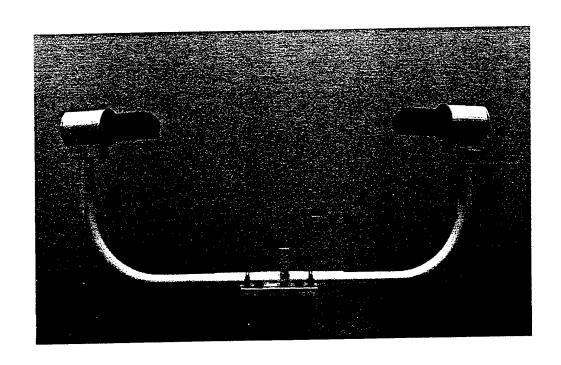
PHOTO 1. LOOK-OUT VISIBILITY SENSOR

The original RVR visibility sensor, commonly referred to as the Look-out VS, utilized transmitter and receiver components (ref. photo 1) that were oriented parallel to the ground. This design configuration had lead to problems in sensor performance during precipitation events.

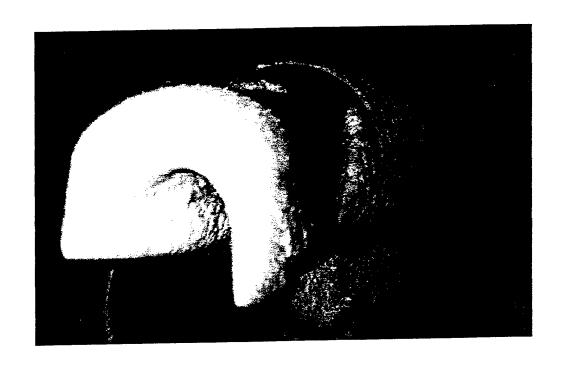
It was noted during the events, that snow accumulated on unheated areas on the underside of the sensor hood (e.g., ref. photo 2). Additionally, snow clogging occurred on the sensor window. Because the sensor uses forward scatter technology, light impediments (e.g. VS clogging) to the scatter volume can result in higher than actual RVR readings.

PHOTO 2. VISIBILITY SENSOR SNOW CLOGGING

Following a review of RVR VS performance at St. Johns and reports of precipitation related outages at other test sites, it was decided that modifications to the sensor heads would be required to correct the observed problems. For risk reduction purposes, a dual path approach was taken in correcting the problems.

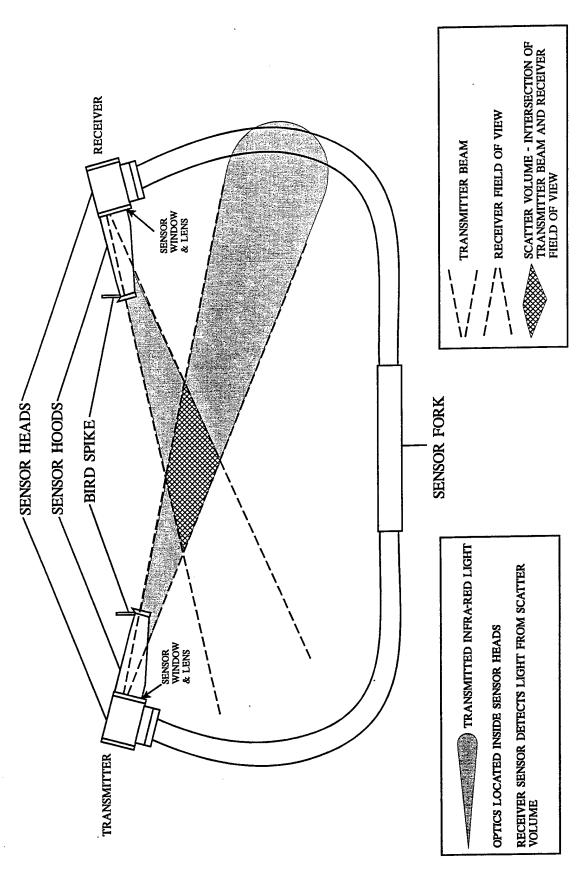
Figure 1. Look-Down Visibility Sensor Components

Further analysis performed by the Volpe National Transportation Systems Center revealed that the optimum sensor angle should be 42° (ref. figure 1).

This refers to a heater in the form of a blanket that covered the entire hood except for the flange area (ref. figure 1). The heater was located on the underside of the hood.

Although the addition of a bird spike (ref. figure 1) was incorporated in the design of the Look-Down VS, this component was not used in the CRREL test

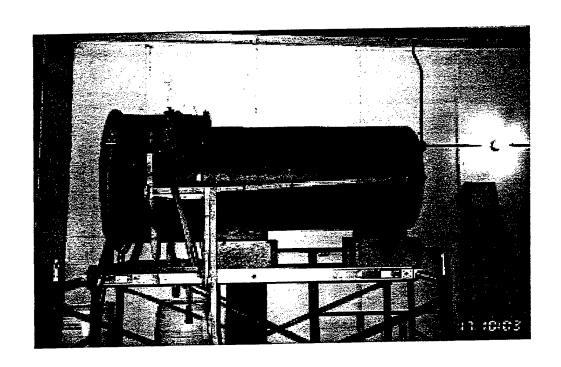
PHOTO 3. CYLINDRICAL WIND TUNNEL

The cylindrical wind tunnel (ref. photo 3) was used for some of the initial tests, but it was discovered that the rectangular wind tunnel (ref. photo 4) provided a more even snow output. The cylindrical wind tunnel produced erratic and uneven amounts of snow that were often bursty. For these reasons, most of the tests utilized the rectangular wind tunnel.

The snow volume was chunky and was propelled in spurts rather than in a consistent stream. More snow hit the transmitter and receiver components of the sensor than was anticipated. The design of the wind tunnel was determined to be the cause of these problems. Due to all of the aforementioned problems, the baseline determination from this test was not considered reliable.

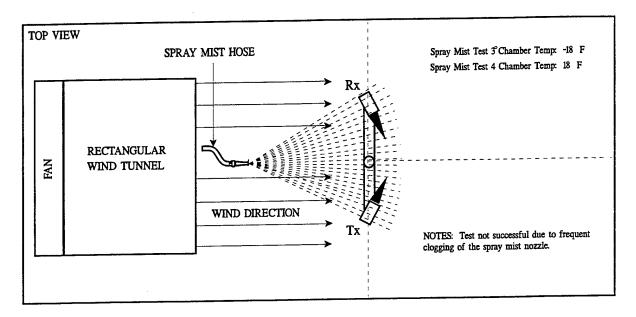
Figure 6. Spray Mist Test - Location: ROWPU Chamber

As in the previous test, there were many stoppages due to clogging of the spray mist device. In addition, some ice build up was noted on the VS hood. As a result, the test objective was not fulfilled.

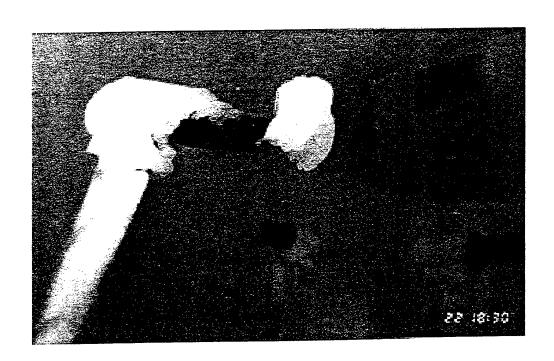
PHOTO 5. ICE CONGLOMERATE FORMATION

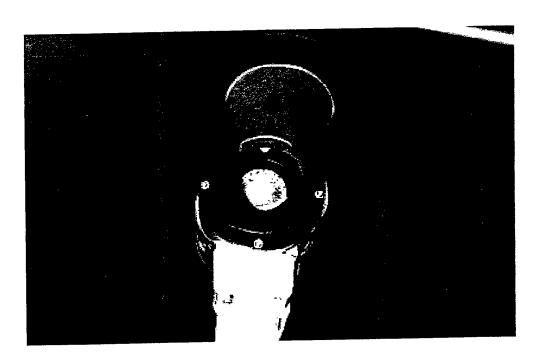
The fact that a larger clog was formed suggests that the de-ice heater should not be disabled at 1.4°, despite the inadvertent drop in chamber temperature. However, a repeat of this test at a constant temperature would most likely result in less performance degradation with a deactivated de-ice heater.

PHOTO 6. LOOK-DOWN VS SNOW CLOG "THIN" AT CENTER

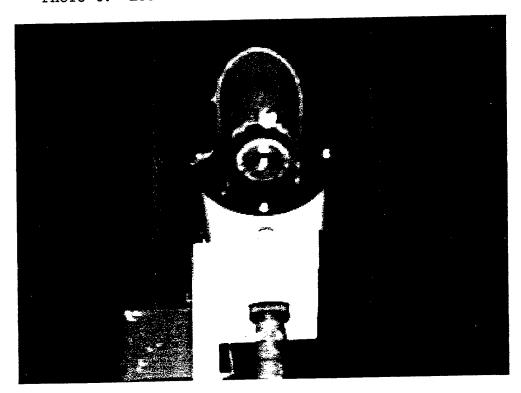
PHOTO 7. ALS "DONUT CLOG"
